# Manhole Inspection Summary

Manhole # S11GG\_012MH

Insp Date: **11/1/07 12:08 PM**

**Location** Address: **2924 BAKER ST**

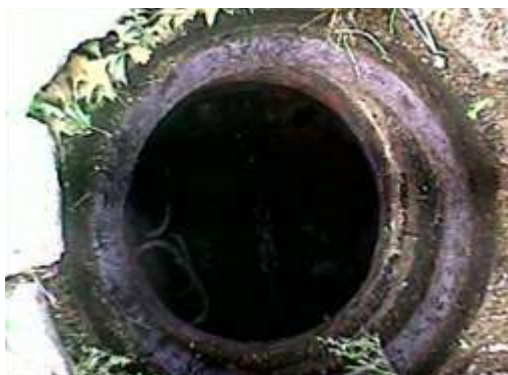
Defect 1

**Frame** Offset: **3** (in.) Condition: ☒ Sound ☐ Cracked ☐ Leaks

FRAME OFFSET

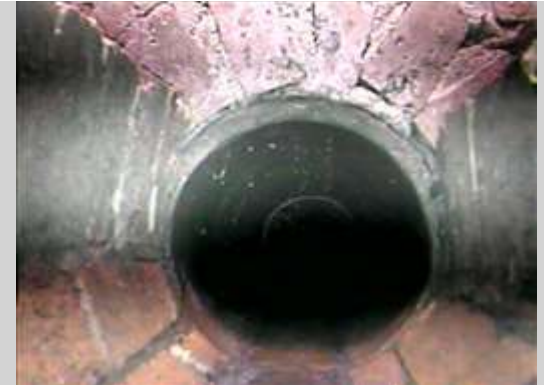
12 O'Clock Outflow

8 in. Circular Gravity Sewer  
Pipe Out @ 12 O'Clock

Pipe Material: **Clay** ☐ Pipe Lined

Invert Depth: **6.78** (ft.) Flow Characteristics: **Fast**

Deposits: ☒ None ☐ Mud ☐ Sludge ☐ Debris ☐ Grease

Infiltration: **None** Pipe Seal Cond: **Sound**

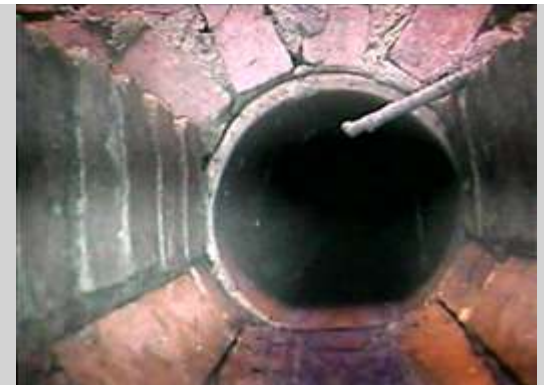
6 O'Clock Inflow

8 in. Circular Gravity Sewer  
Pipe In @ 6 O'Clock

Pipe Material: **Clay** ☐ Pipe Lined

Invert Depth: **6.80** (ft.) Flow Characteristics: **Fast**

Deposits: ☒ None ☐ Mud ☐ Sludge ☐ Debris ☐ Grease

Infiltration: **None** Pipe Seal Cond: **Sound**
